INSTALLATION RESTORATION PROGRAM TECHNICAL SUPPORT  
DOCUMENT FOR RECORD OF DECISION CAPE MERRIMAN AFS (U)  
WOODWARD-CLYDE CONSULTANTS ANCHORAGE AK 18 JAN 88

Scope of Decision: This record of decision and supplemental support document applies to six potential hazardous waste sites identified at Cape Newenham AFS. The recommendations for all six sites are the same; therefore, a single document for the entire installation is warranted.

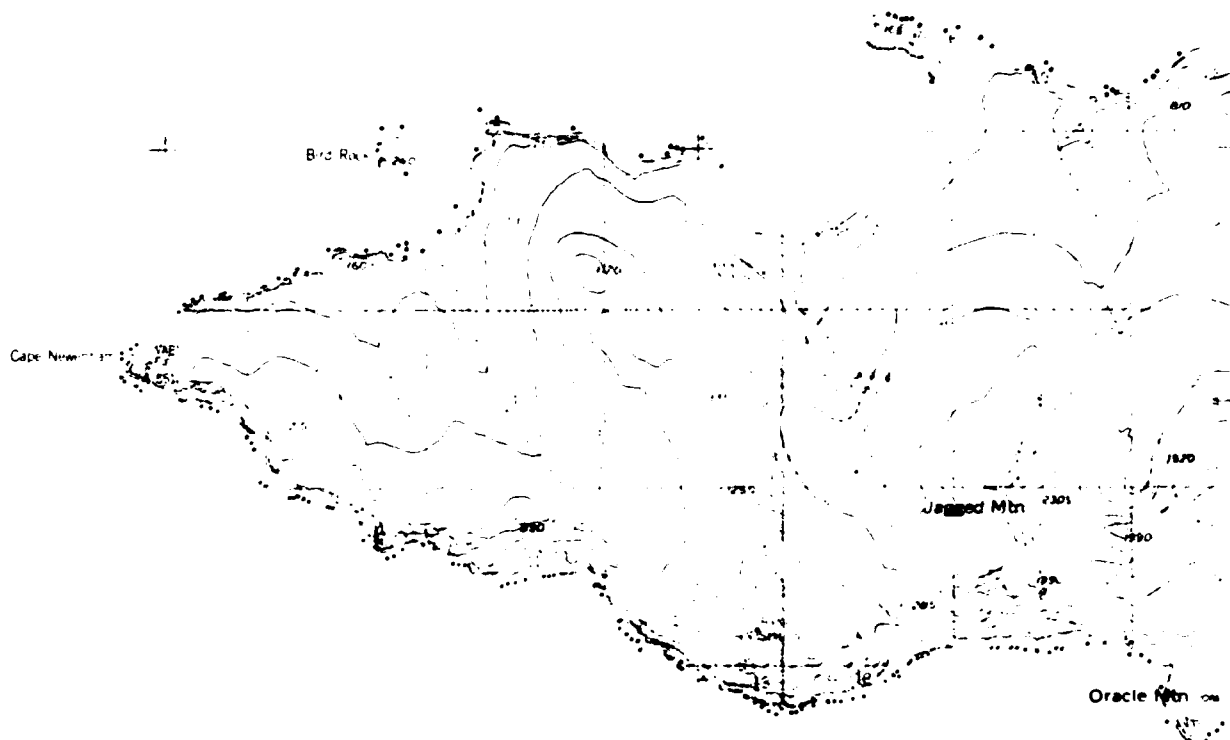
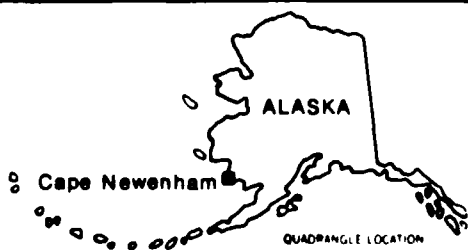
Figure  
1

CAPE NEWENHAM AFS  
TOPOGRAPHIC MAP

The Cape Newenham AFS is located on a small peninsula on the southwest coast of Alaska about 770 km southwest of Anchorage (Figure 1). The Air Force Station consists of approximately 950 hectares surrounded by the Togiak National Wildlife Refuge (NWR). The nearest settlement is Platinum, a Native Alaskan mining community about 50 km to the northwest. The topography in the vicinity of the cape is steep and rocky. One unnamed drainage is found within the boundaries of the installation. The creek flows through the valley, past the airstrip and into Kuskokwim Bay. The rugged terrain of the area supports a dwarf, shrubland, alpine tundra.

The upper valley in section 7 of Cape Newenham AFS (see Figure 1) is the principal recharge zone of ground water for the installation. Water collects and drains northward, downslope, into shallow aquifers and surface streams. The valley near the Lower Camp (el. 212 m) consists of a thick zone (approx. 30 m) of permeable, coarse grained talus and alluvium. This material generally contains ground water at shallow depths which may occur under artesian conditions (Eng. Sci. 1985). Permafrost may occur as isolated lenses, but is restricted to fine-grained, unconsolidated sediments (Eng. Sci. 1985).

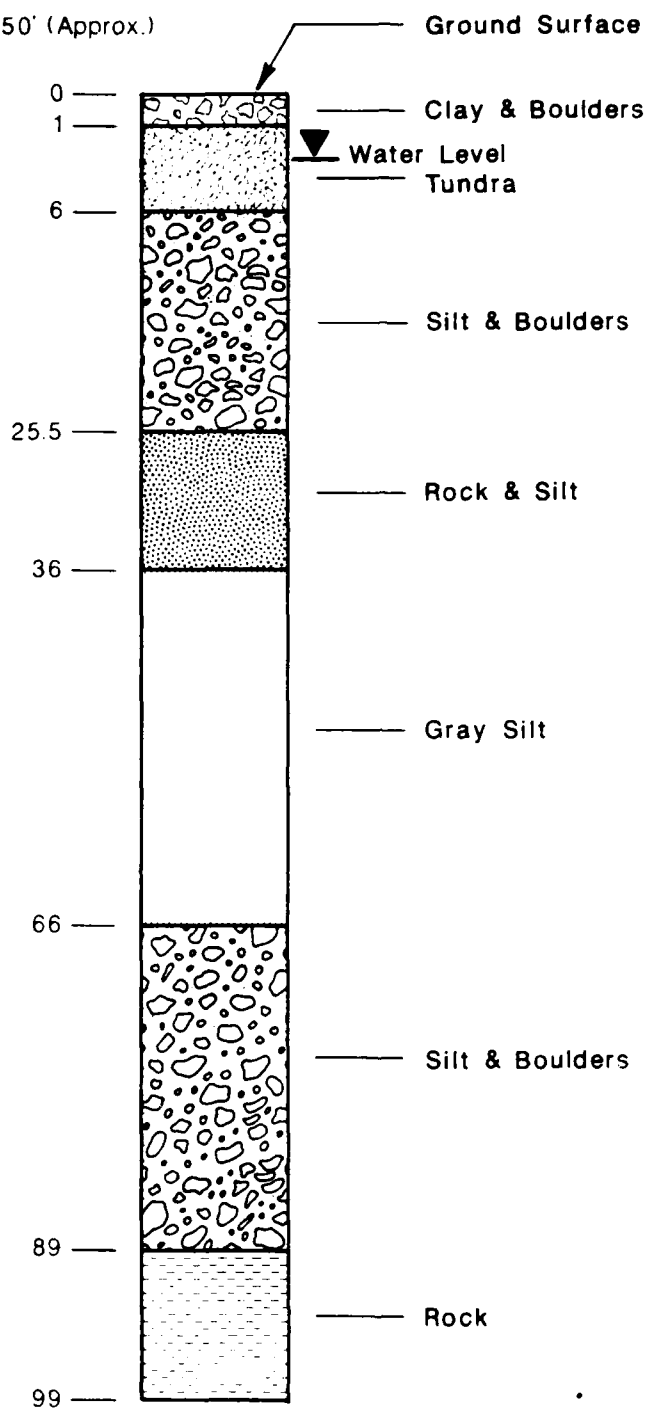
DEPTH IN FEET BELOW GROUND SURFACE

Note: Water Level Measured June 17, 1975  
in Lower Camp Area

Source: Modified from U.S. Geological Survey  
Water Resources Division File Data,  
undated.

The geology is primarily a fractured volcanic greenstone as bedrock with varying thicknesses of accumulated talus and alluvium overlying. The accumulated residuum is thin at higher elevations but increases in depth at lower elevations. A well log taken near the Lower Camp shows depth to bedrock as 89 feet (27 meters). The log shows the constituents of the poorly sorted talus/alluvium (Figure 6). Permafrost may occur as isolated lenses in the fine silts.

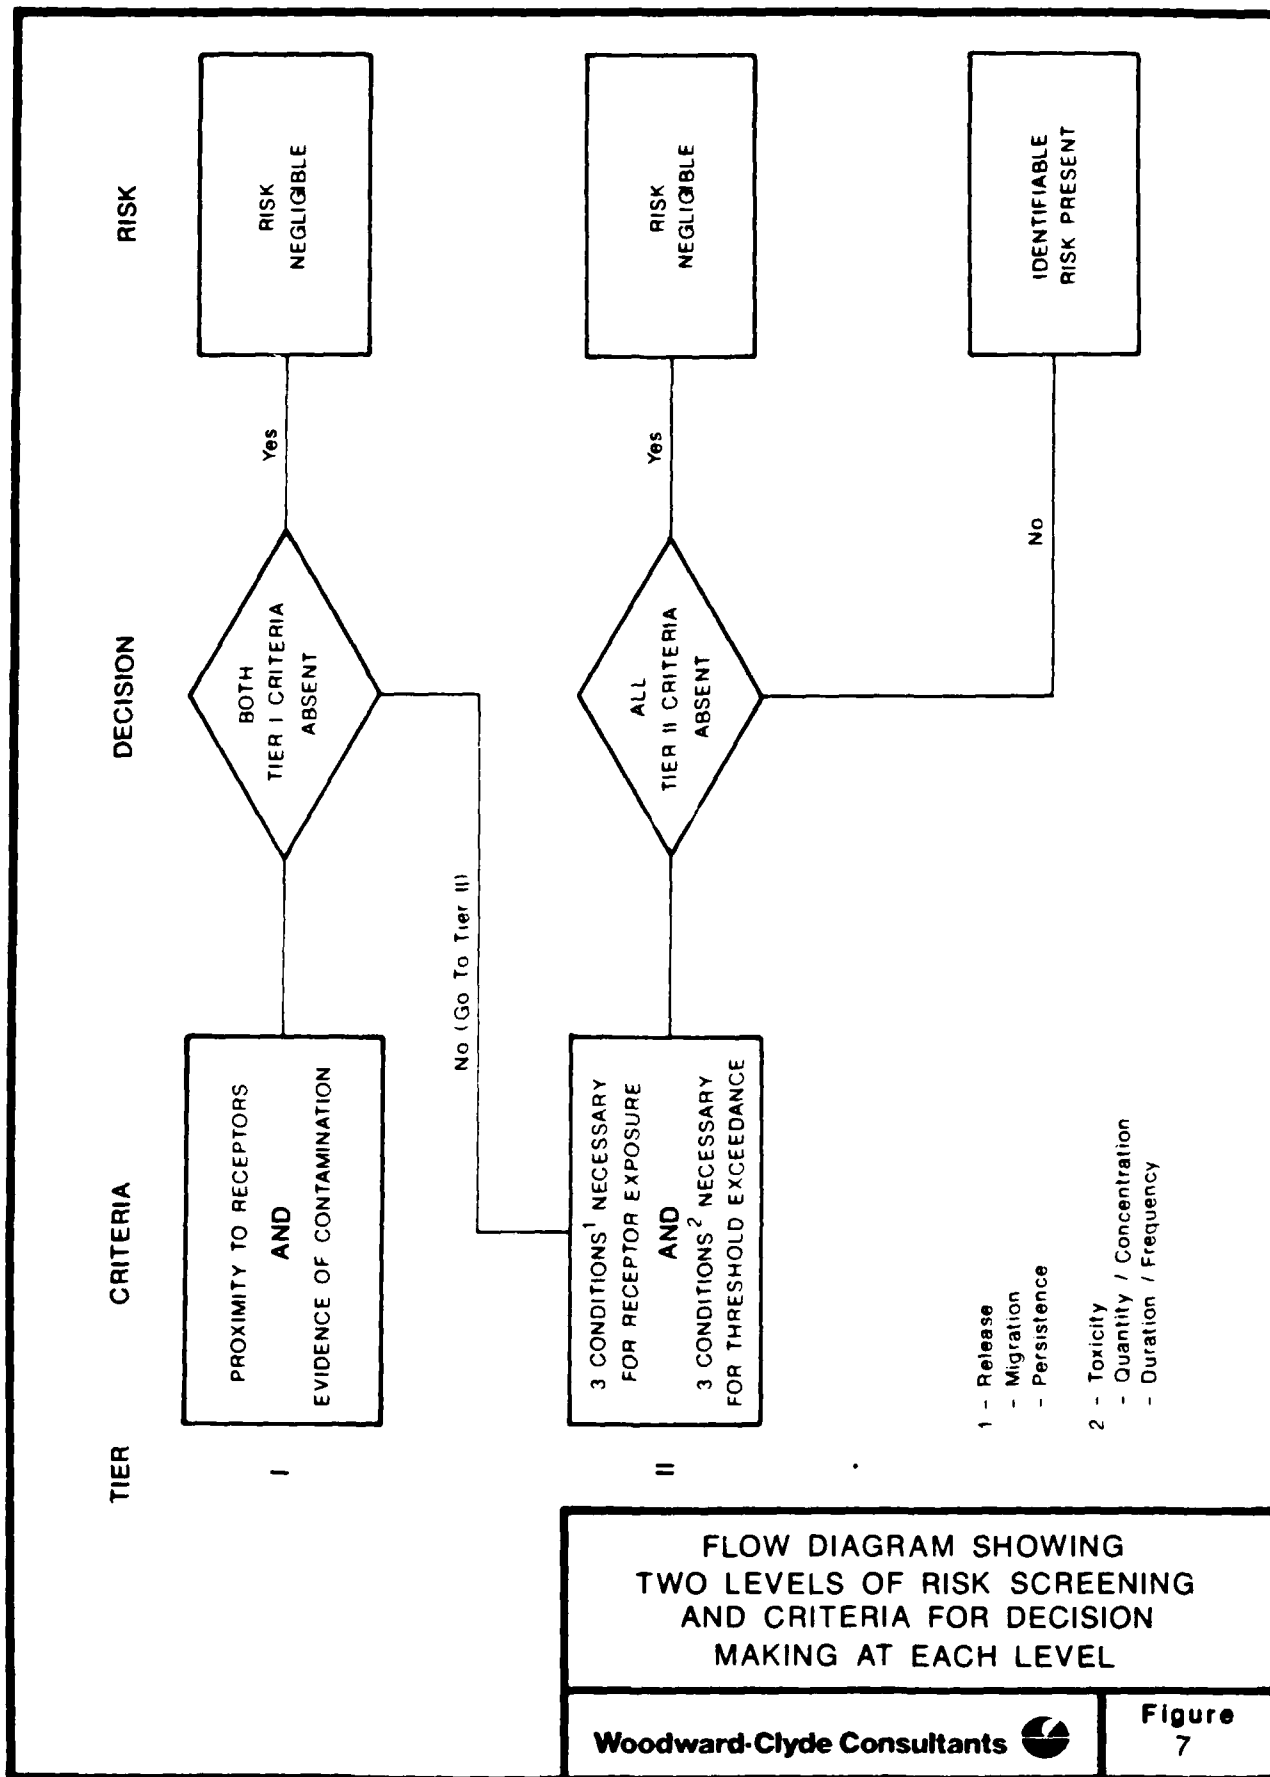
For the purposes of assigning risk levels to a site, a two-tiered hierarchical decision scheme is employed (see Figure 7). At tier I, an initial assessment of the presence of contaminants and the proximity of sensitive receptors is made. This determination is made by reviewing historical records, observations from the site visit, or other evidence. If the available evidence does not indicate that contaminants have been released at the site, and if the site is not close to sensitive receptors, then the probability of risk is considered negligible. In this case no further action will be recommended.

However, if it is concluded that the site is, or possibly has been, contaminated with hazardous or toxic substances, or if the site is in close proximity to sensitive receptors, the screening proceeds to tier II. The approach to tier II is deductive. First, receptors and the conditions necessary for exposure must be identified. Second, the conditions necessary for exceedences of thresholds must be established. Then the actual conditions at the site are compared to the specified conditions. In actuality, all the specified conditions must be present for significant risk to exist. However, the risk screening procedure used here is conservative in that it assumes a negligible risk only if all the conditions are absent. Thus, if all the necessary conditions are absent, then a negligible risk is deduced. Likewise, if the status of a specified condition cannot be determined at a site but there is no reason to suspect that it exists, and all other conditions are absent, the site will be assumed to have negligible risk. If not all of the conditions are absent or not suspected, then the site represents some identifiable level of risk.
